City of Somerville — RFP nº 12-71

ADA Self-Evaluation (as basis for Transition Plan)

Prepared by
Institute for Human Centered Design
August 12, 2013

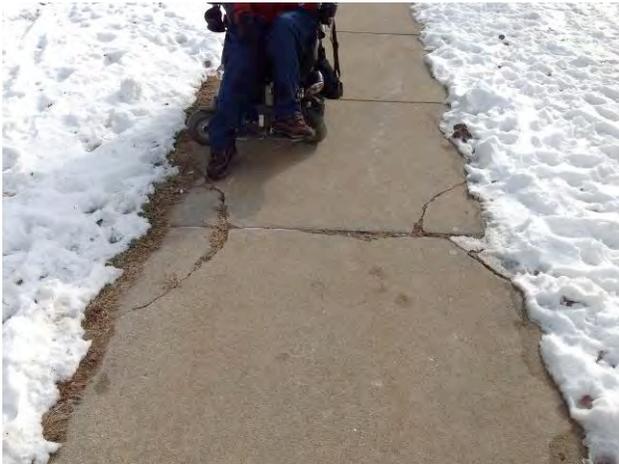
Photo 2

The entrance to the library is directly connected to the walkways that lead to the High School and the sidewalks along Highland Avenue and Walnut Street. Although the sidewalks are in reasonable condition, deteriorated surface within the walkways can become tripping hazards to the public and staff. (Photo 2) Further, some bricks are missing at the entrance and book drop.

1. Repair or replace all degraded walking surfaces, including the concrete walkways and brick walkway near the entrance.
2. Replace curb ramps adjacent to parking.
3. Provide handrails and a level landing at the new walkway to corner of Highland and Walnut.
4. Plan for the replacement of handrails along stairways down to Walnut Street and the rear surface driveway.

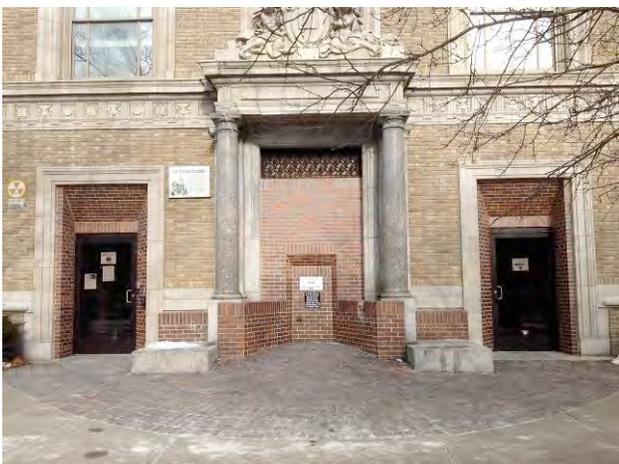
Photo 3

The building has one public at-grade entrance on Highland Avenue. This door, as well as the exit door next to it, is operated by an automatic door opener. (Photo 3)

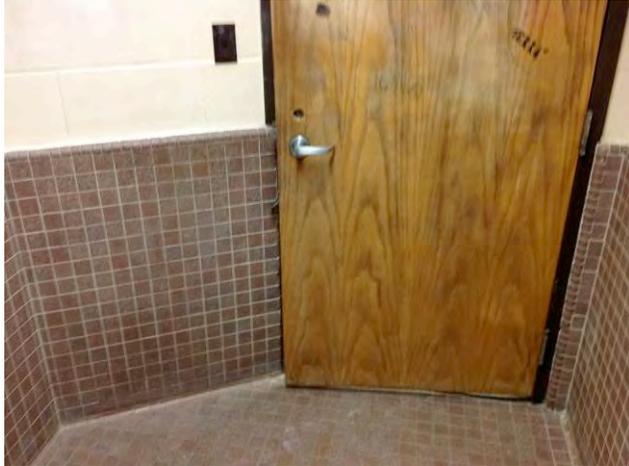
Photo 4

Throughout the building, several single- and double-leaf doors exceed the maximum allowable force required to open them and do not have the minimum clear width for accessible doors. In the single-user toilet rooms on the first floor, doors lack the minimum maneuvering clearance required to open them. Additionally, numerous doors have non-compliant hardware. (Photo 4)

1. Install automatic door openers on the single-user toilet rooms on the first floor, unless major structural work is undertaken to remove angled wall adjacent to doors.
2. When doors do not have the minimum clear width for accessible doors, either keep them open during regular hours or replace them with wider doors.
3. Replace door knobs with lever hardware.
4. Create a comprehensive maintenance program and schedule to check and adjust the opening force of all exterior and interior doors. Where not possible, either keep heavy doors open during regular hours or add automatic openers.

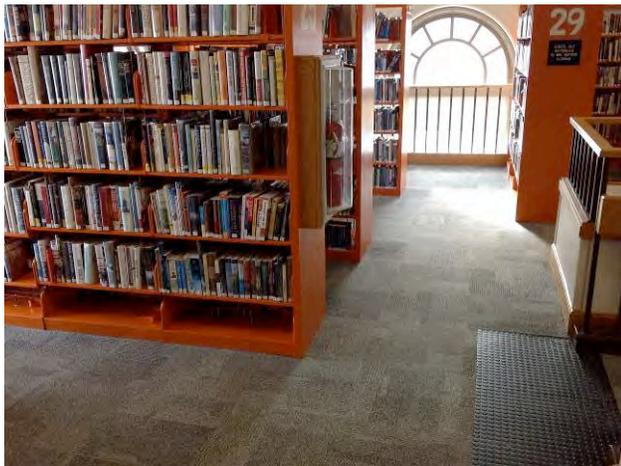
Photo 5

On the circulation path on the mezzanine level, a fire extinguisher mounted on one bookshelf is a hazardous protruding object that increases the possibility of injury to visitors and staff. (Photo 5)

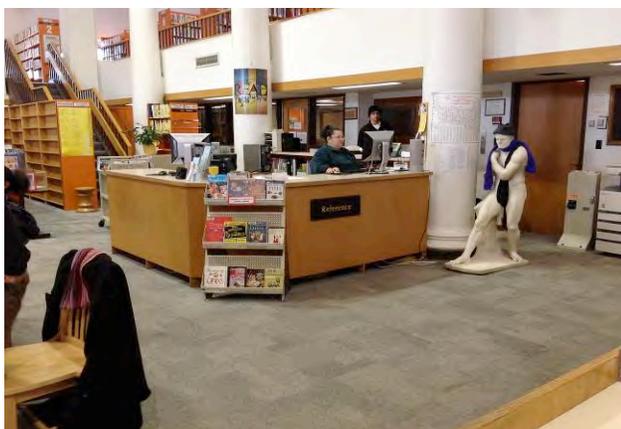
Photo 6

On the second floor, the circulation counter exceeds the maximum allowable height for visitors using wheeled mobility devices or who are of short stature. (Photo 6)

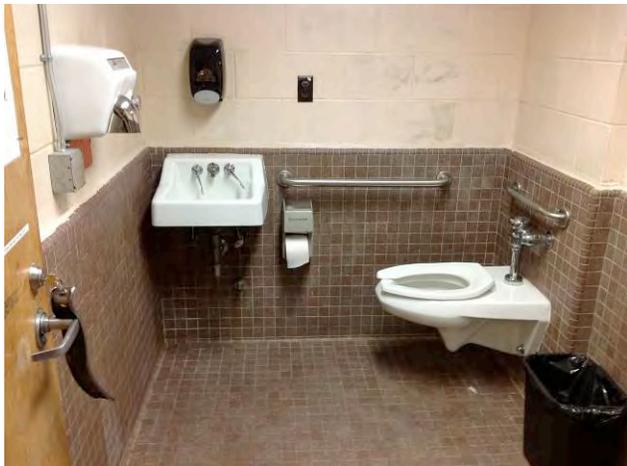
Photo 10

A set of single-user toilet rooms (one for each gender) for public use are located on the first floor. These amenities are kept locked and keys are provided at the circulation counter upon request. Both toilet rooms are inaccessible because the lavatories are too high, plumbing underneath lavatories are not protected, mirrors are not provided, faucets are non-compliant, and the approach to the toilet is obstructed by the lavatory. (Photo 10)

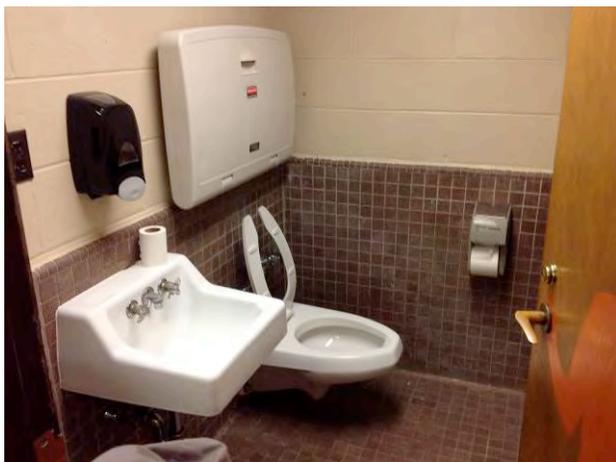
Photo 11

A set of single-user toilet rooms (one for each gender) for children use are located inside the Children's room on the first floor. Both toilet rooms are inaccessible because the doors are 28 inches wide, the plumbing underneath lavatories are not protected, faucets are non-compliant, grab bars are missing, and a wall-mounted changing station is located above the toilet. (Photo 11)

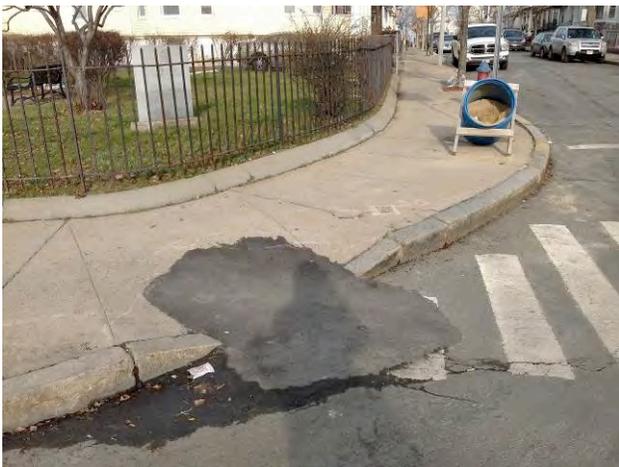
Photo 2

The entrance to the library is directly connected to the sidewalks along Broadway and Michigan and Illinois Avenues. Although the sidewalks are mostly in reasonable condition, deteriorated curb ramps lacking level landings can become tripping hazards to the public and staff. (Photo 2)

1. Replace the curb ramps at the nearby intersections.

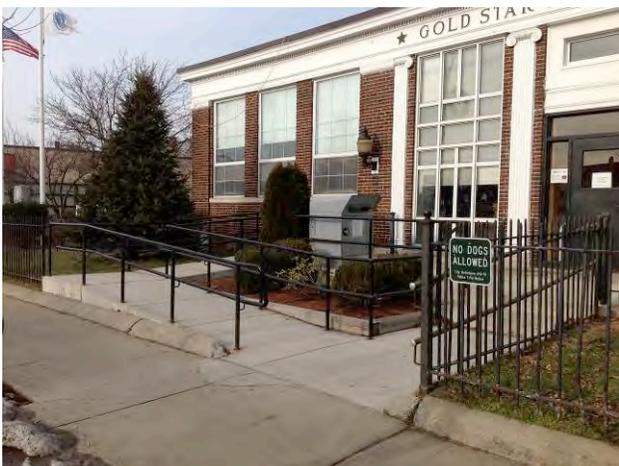
Photo 3

The building has one entrance in front of the building on Broadway. This entrance is accessible via a ramp, although the ramp does not meet the minimum allowable width, is missing the required drop-off edge protection on both sides, and slightly exceeds the maximum allowable running slope. (Photo 3)

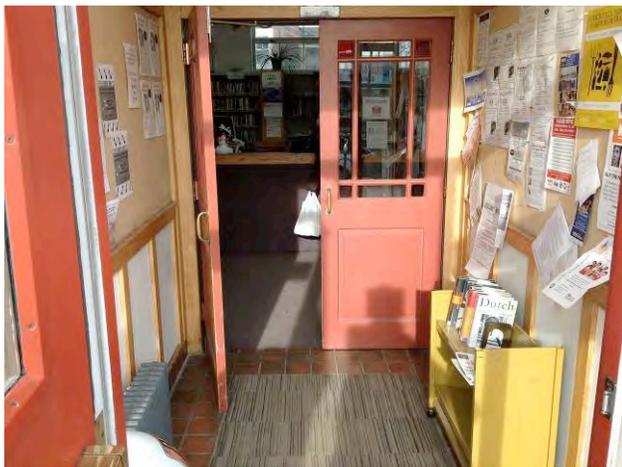
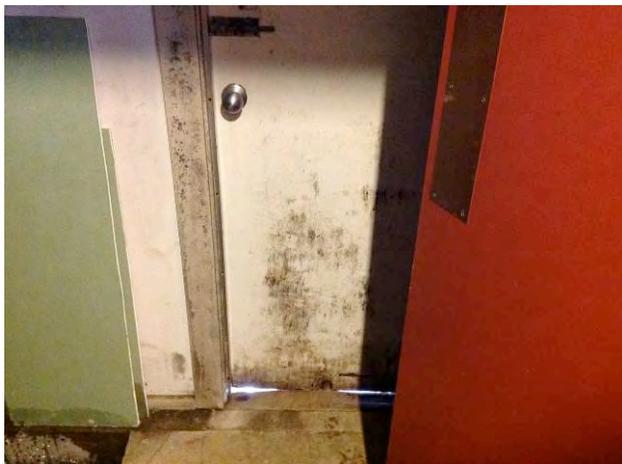
Doors leading to the office and the rear exit have non-compliant hardware and do not have the minimum maneuvering clearance required to open them. (Photos 4, 5 and 6)

1. Create a comprehensive maintenance program and schedule to check and adjust the opening force of all exterior and interior doors. Where not possible, either keep heavy doors open during regular hours or add automatic openers.
2. In the vestibule, either keep the interior double-leaf doors open during regular hours or replace them with a wider single-leaf door.
3. Replace door knobs with lever hardware.

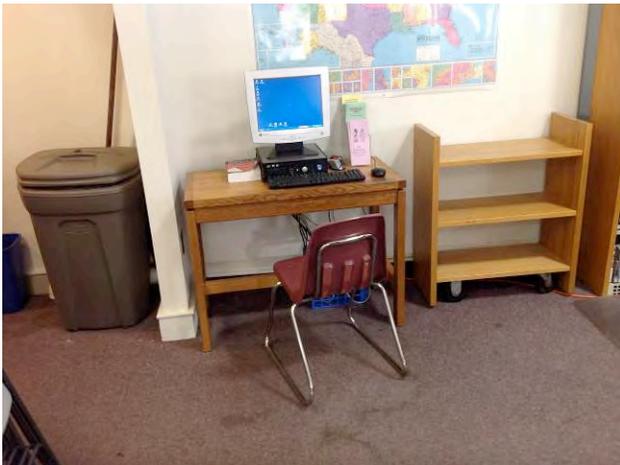
Photo 8

Specific workstations such as those with computers do not provide the require knee and toe clearance. (Photo 8)

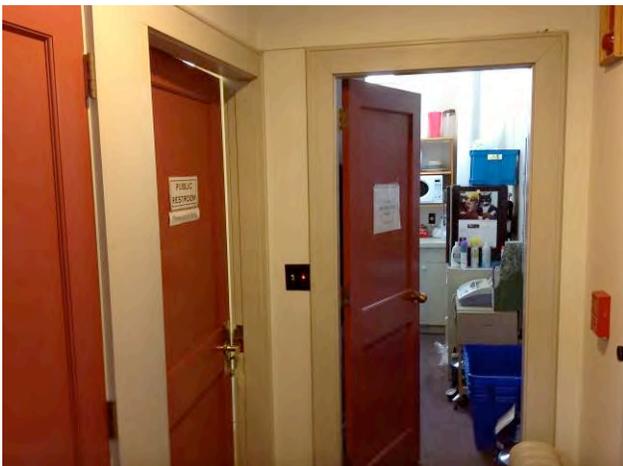
Photo 9

Very little signage is provided at this facility and not all permanent rooms and spaces are properly identified with ADA-compliant signs. (Photo 9)

Toilet rooms are not identified with accessible signage. (Photo 9)

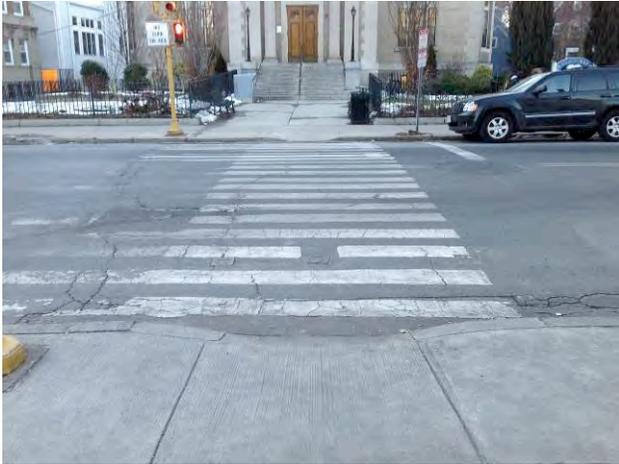
Photo 1

The entrance to the library is directly connected to the sidewalk along College Avenue. Although the sidewalks are in reasonable condition, deteriorated and excessively sloped curb ramps can become tripping hazards to the public and staff. (Photo 1)

1. Replace the curb ramps leading to the front entrance.

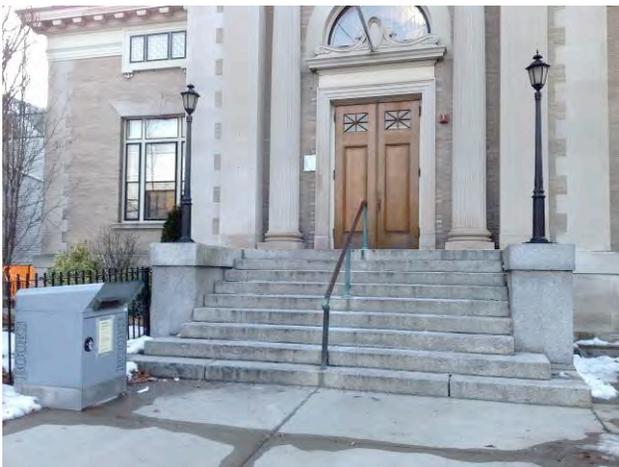
Photo 2

The building has entrances on two sides – in the front on College Avenue and at the rear along the parking lot. Neither entrance is accessible since stairways are provided to both the first floor and basement level. As such, strollers and walkers are routinely parked outdoors exposed to the weather. (Photos 2 and 3)

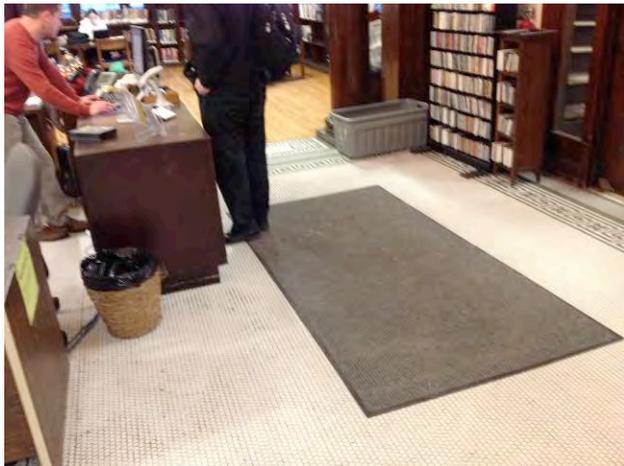
Photo 5

At the front entrance as well as other circulation areas within the first floor, several weather mats are not secure and can become tripping hazards to visitors and staff. (Photo 5)

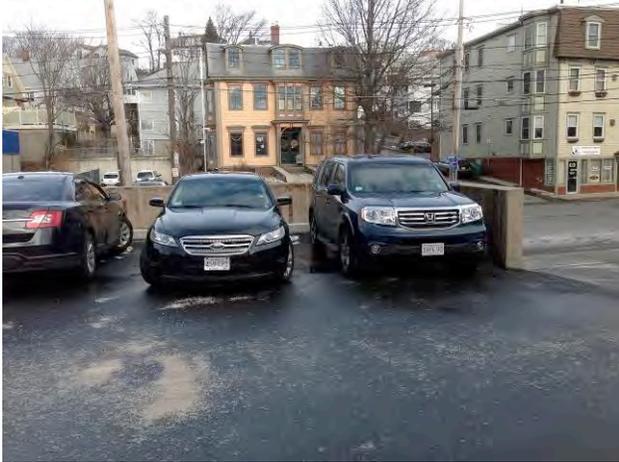
Photo 1

Off-street parking for staff and public is provided at this facility. Although two accessible parking spaces for public are provided in the parking lot off Washington Street, the required access aisle and signs are missing. (Photo 1)

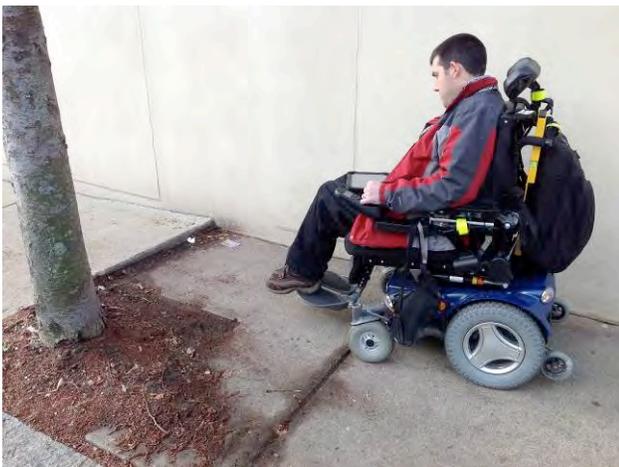
Photo 2

Exterior sidewalk access to the Public Safety Building is problematic because of non-compliant curb ramps and sidewalks with deteriorated surface that can become tripping hazards to the public and staff, especially along Merriam Street. (Photos 2 and 3)

1. Repair or replace all degraded curb ramps and walking surfaces leading to the Public Safety Building.

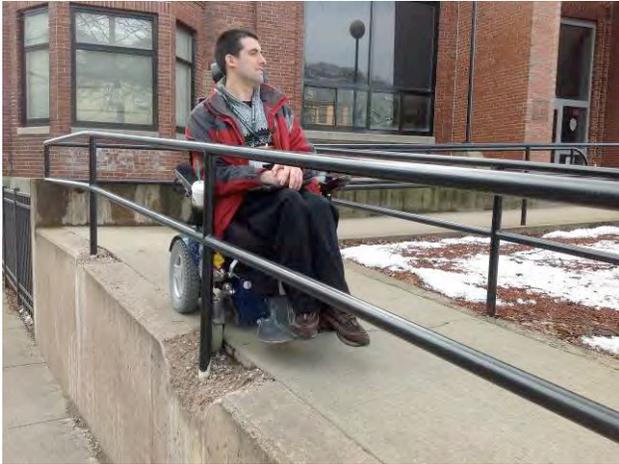
Photo 4

On Washington Street, the entrance is accessible via a stairway and a ramp. Although the ramp is generally usable by persons with disabilities, it does not meet all of the requirements of applicable accessibility standards, such as deteriorated surface, missing drop-off edge protection on both sides, and non-compliant handrail at the top of the ramp. (Photo 4)

On Somerville Avenue, the entrance is accessible via a series of stairways and a ramp. Although the ramp is generally usable by persons with disabilities, it does not meet all of the requirements of applicable accessibility standards. Not only are the handrails on both sides non-compliant, dumpsters are also placed against them. (Photo 4)

1. On both ramps leading to the entrances, replace or modify handrails and repair deteriorated surface.
2. Install compliant handrails on both sides of the stairways leading to both entrances of Public Safety Building.

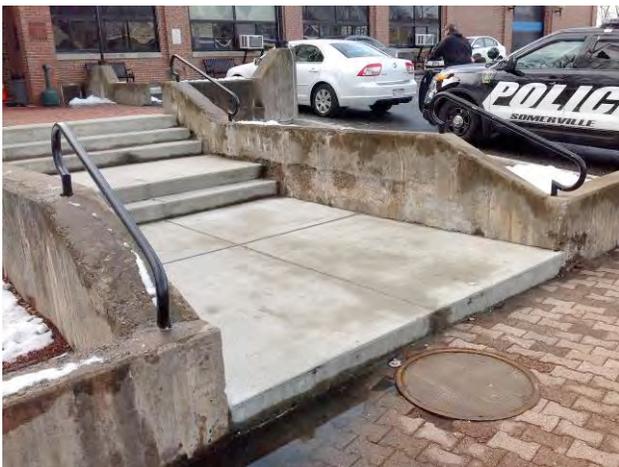
Photo 5

The stairway that leads to this entrance offers non-compliant handrails on both sides. (Photo 5)

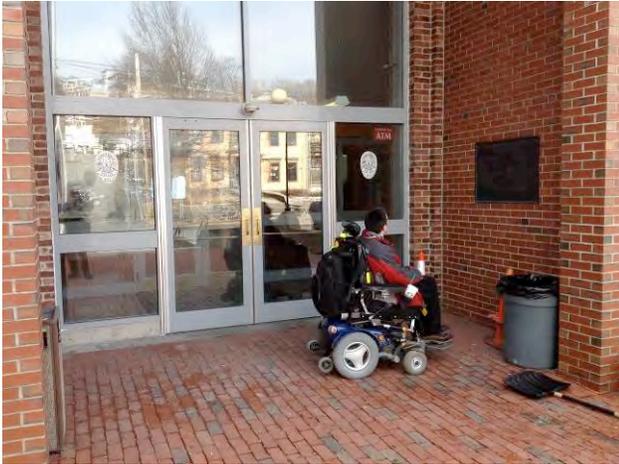
Photo 7

At the entry vestibule of the Washington Street entrance as well as the toilet rooms on the first floor, interior doors exceed the maximum allowable force required to open them. (Photo 7)

1. Replace door knobs with lever hardware.
2. Create a comprehensive maintenance program and schedule to check and adjust the opening force of all exterior and interior doors. Where not possible, either keep heavy doors open during regular hours or add automatic openers.
3. Provide an automatic opener wherever doors do not have the required maneuvering clearance on their latch side. Prioritize entry doors and doors to toilet rooms.

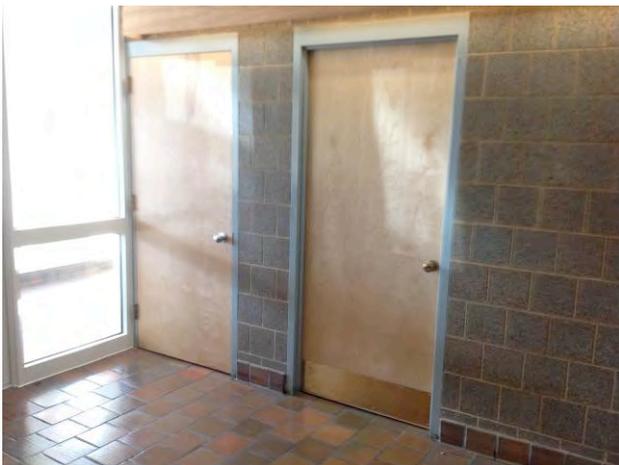
Photo 8

Additionally, numerous doors on all floor levels have non-compliant hardware and do not have the minimum maneuvering clearance required to open them. (Photo 8)

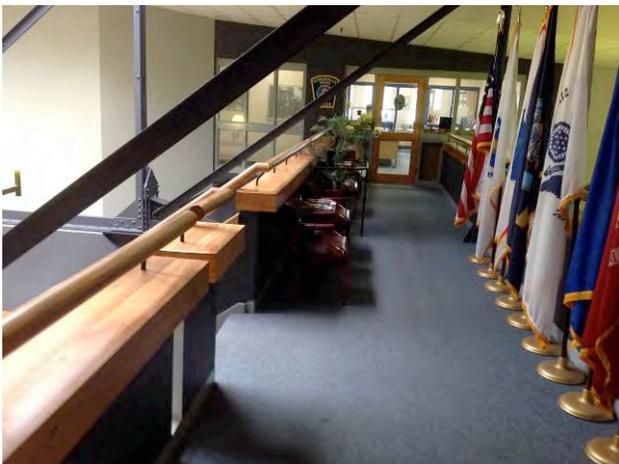
Photo 9

On the second floor, a structural metal support near the stairway increases the likelihood of injuries among people with low or no vision or others who may be unobservant. (Photo 9)

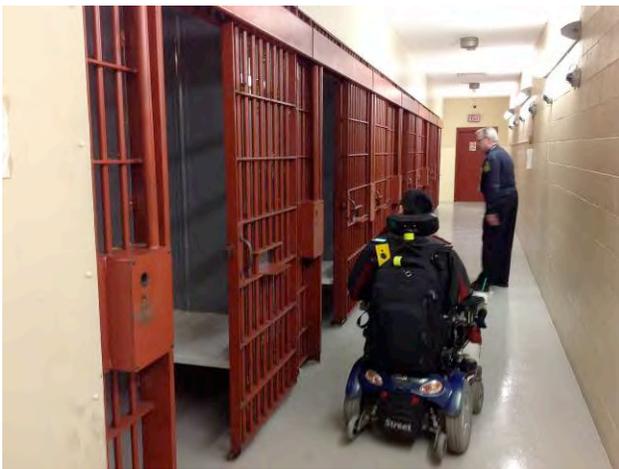
Photo 11

At the basement level, no accessible holding cells are provided. (Photo 11)

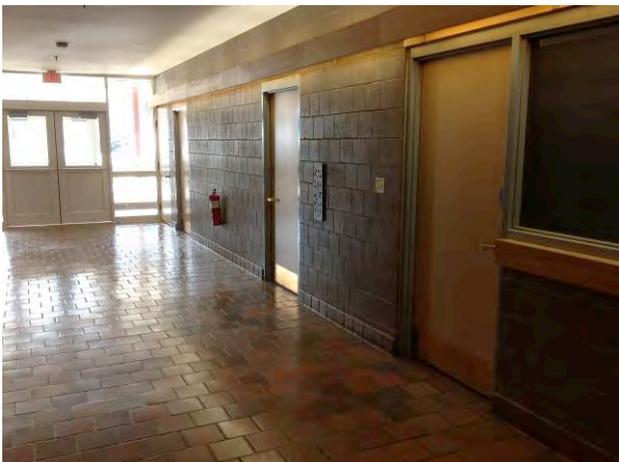
Photo 12

Very little signage is provided at this facility and not all permanent rooms and spaces are properly identified with ADA-compliant signs. (Photo 12)

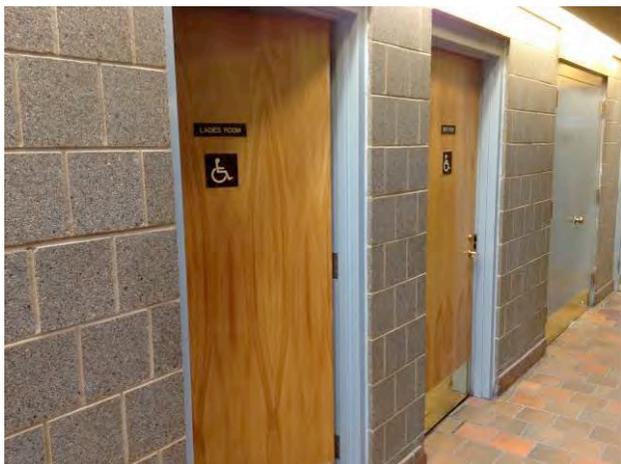
Photo 15

Toilet rooms are not identified with accessible signage. (Photo 15)

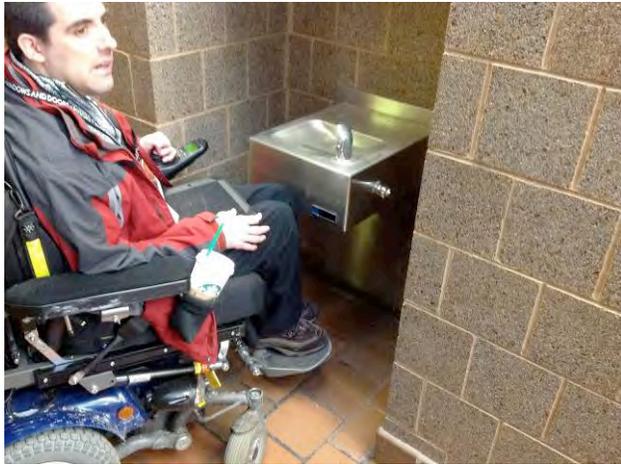
Photo 16

In the lobby on the first floor, the drinking fountain does not provide the required knee clearance. An accessible alternative water cooler is not provided. (Photo 16)

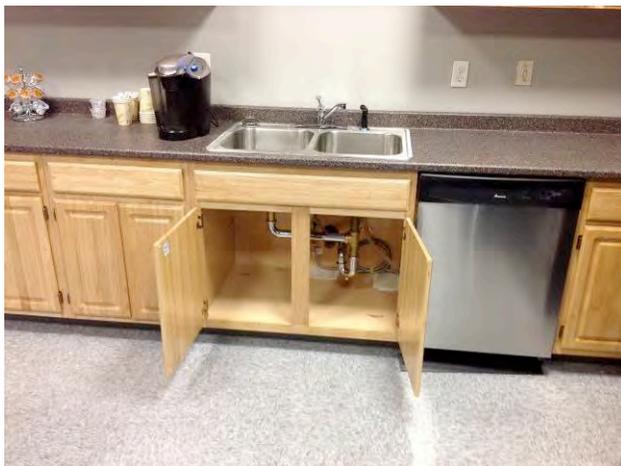
Photo 17

On the basement level, the kitchenette was renovated recently; however, it lacks clear floor space and an accessible sink, among other items. (Photo 17)

1. Short Term: Ensure policies are developed to address employee accommodation requests.
2. Long Term: As kitchenettes are replaced, ensure that replacements meet all ADA/MAAB requirements.

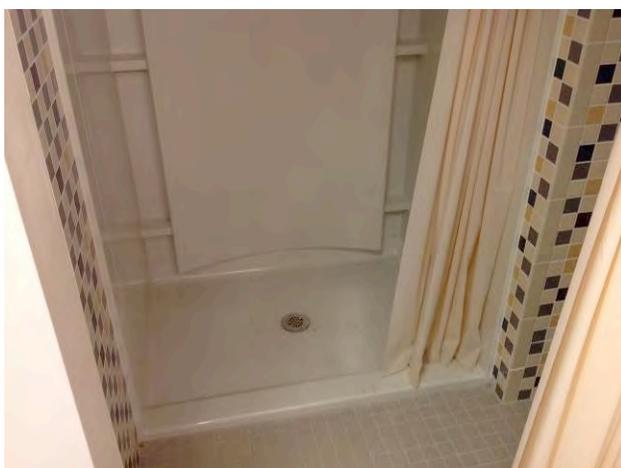
Photo 18

On the basement level, a set of multi-user locker rooms (one for each gender) for staff use were renovated recently; however, they are completely inaccessible. (Photo 18)

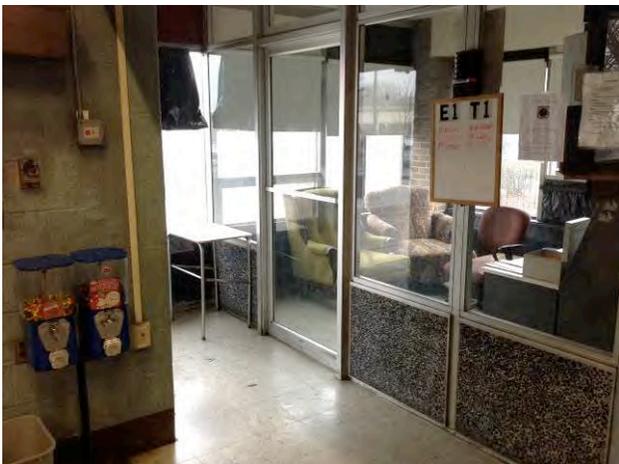
Photo 3

Once inside, a table obstructs the path to the dispatch office. (Photo 3)

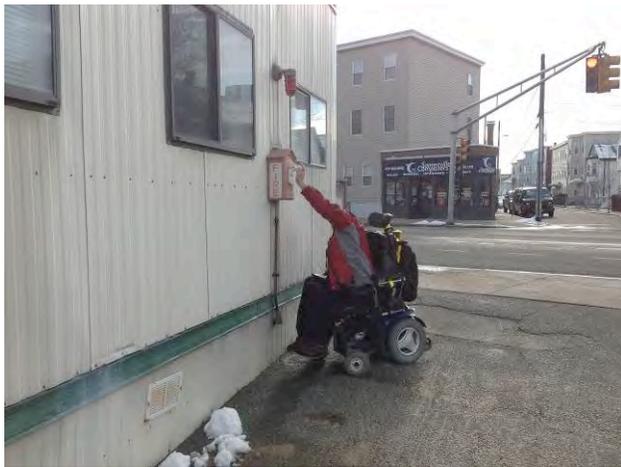
Photo 2

A trailer that serves as the crew sleeping quarter is attached to the apparatus bay on the basement of the Public Safety Building. The apparatus bay can only be accessed through a very steep driveway or stairways. None of the employee areas in this facility are accessible. On the side of the trailer, an emergency call box is not on an accessible route since it is placed at about five feet above the steep driveway. (Photo 2)

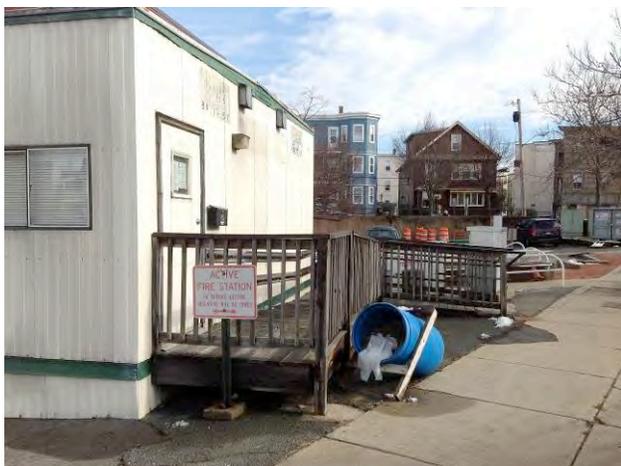
Photo 3

While most fire stations have not had any accessibility updates in many decades, there has been an attempt to increase the accessibility at Engine 3 with the installation of a ramp near the entrance on Somerville Avenue. Although the ramp may have been code-compliant at the time of its installation, it does not meet the minimum requirements of the current accessibility laws and regulations. In fact, the ramp has become a hazard due to the lack of maintenance. (Photo 3)

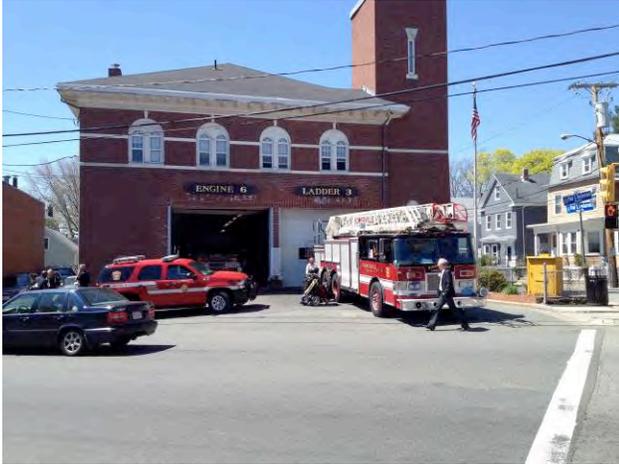
Photo 1

Located at the intersection of Broadway and Holland Street, the Teele Square Fire Station is a two-story brick structure with staff spaces above the two-door apparatus bay. (Photo 1)

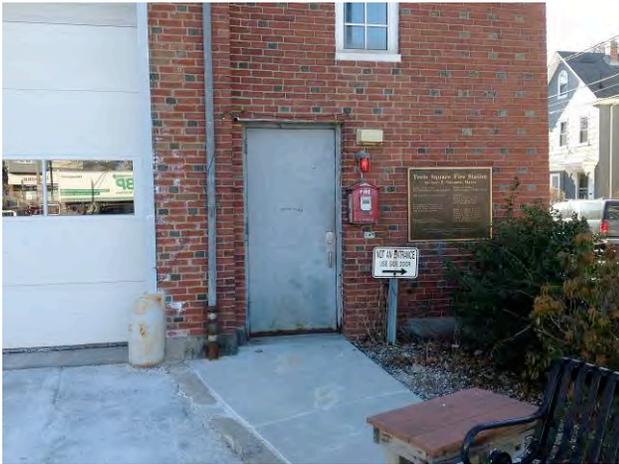
Photo 2

An at-grade entrance is provided at the far right near the intersection; however, this door opens into the egress stairway and a step obstructs the accessible route to the apparatus bay. An emergency call box located near the main entrance is not on an accessible route since it is located above a sign and beyond the concrete walkway. (Photo 2)

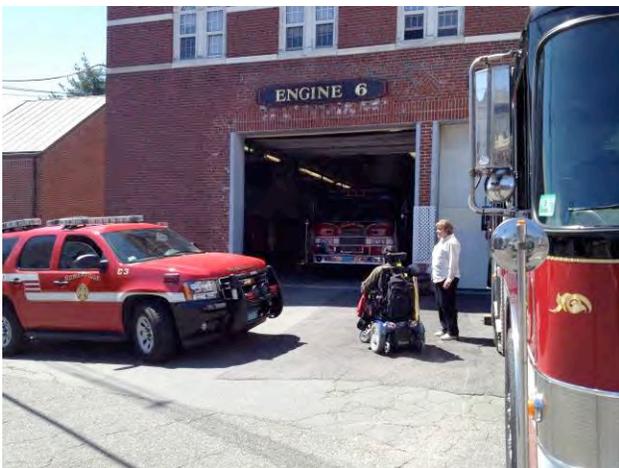
Photo 3

This fire station is also used as a polling place during elections, where the driveway serves as ramp into the apparatus bay. (Photo 3)

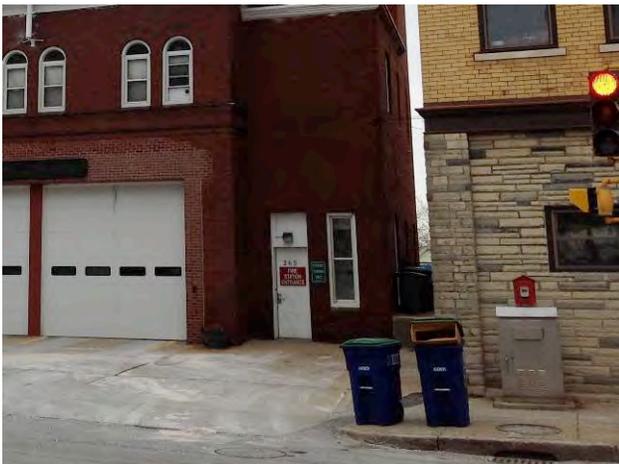
Photo 2

The emergency call box is not on an accessible route since it is located directly above a traffic light control box. (Photo 2)

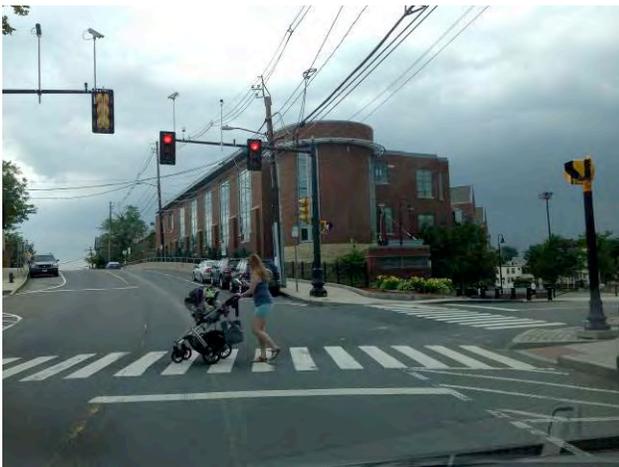
Photo 2

Sidewalks abutting the Argenziano School along Washington and Franklin Streets were rebuilt when the school opened. No major issues were identified apart from portions of sidewalk abutting the soccer field that had cross slopes in excess of 1:50 and catch basins that had openings greater than 1/2 inch and were tripping hazards. (Photo 2)

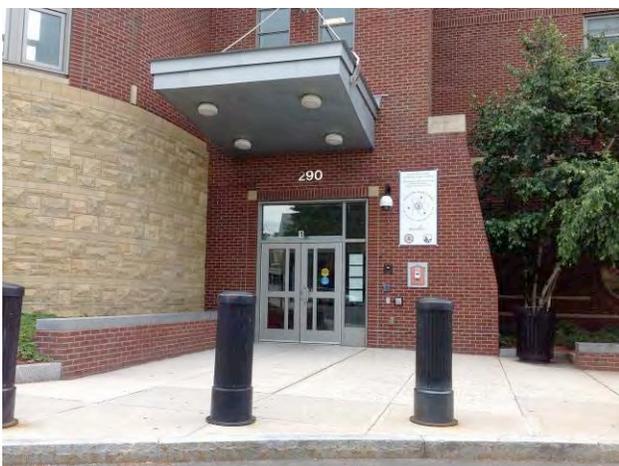
Photo 3

The building has one public entrance on Washington Street as well as locked employee only entrances. Each entrance is at grade and have double doors. The main entrance is visible from the office; however, the intercom lacks accessible signage. (Photo 3)

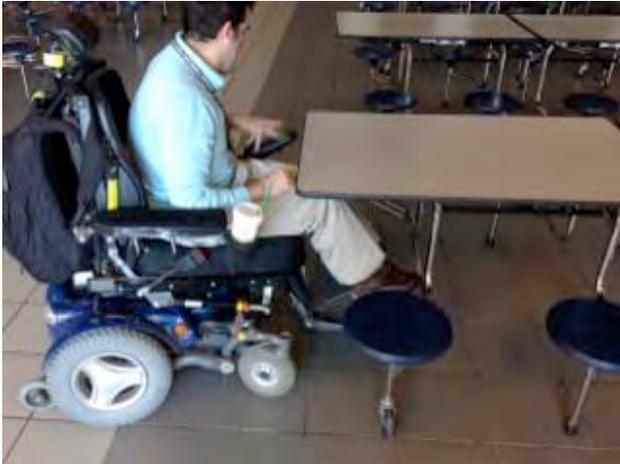
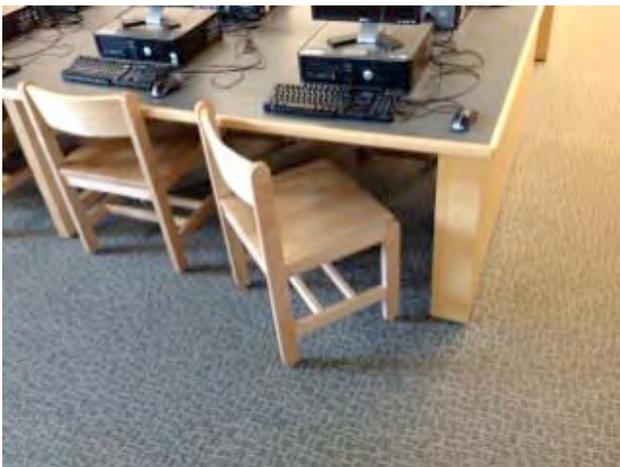
- cafeteria, computer and media lab work surfaces provided less than 27 inches of knee clearance, no accessible stations were found; (Photos 3 and 4)
- specialized work stations such as in the art room may require extended forward reach ranges and or lack knee/toe clearance. (Photo 5)

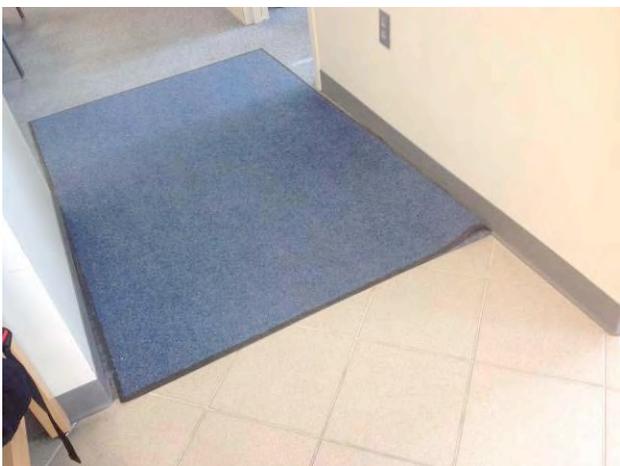
Photo 8

- Unsecured weather mats; (Photo 8)
- Unsecured carpets in classrooms.

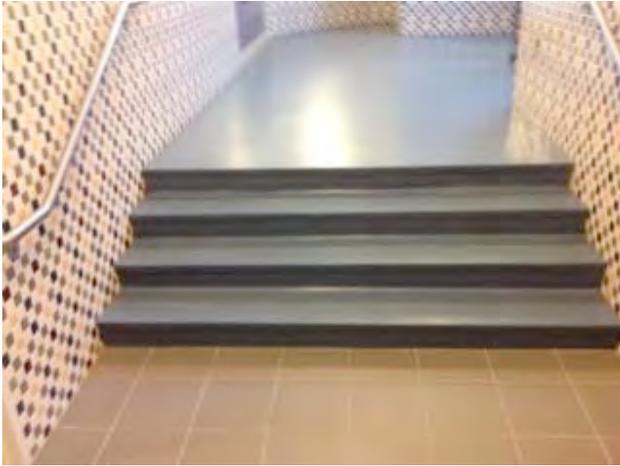
Photo 9

The five steps from the stage appear to conform to Massachusetts Building Code's requirements. However, the stairs are located at a ramp landing where the ramp turns 90 degrees creating a possible safety risk. (Photo 9)

1. Close off stairs at ramp to stage by installing a railing on the top step.
2. Develop policies and procedures to ensure the evacuation of individuals unable to navigate stairs;
3. Acquire Evacuation Chairs.
4. Engage NFPA (Allan Fraser) to assist with staff training and locating of evacuation chairs.

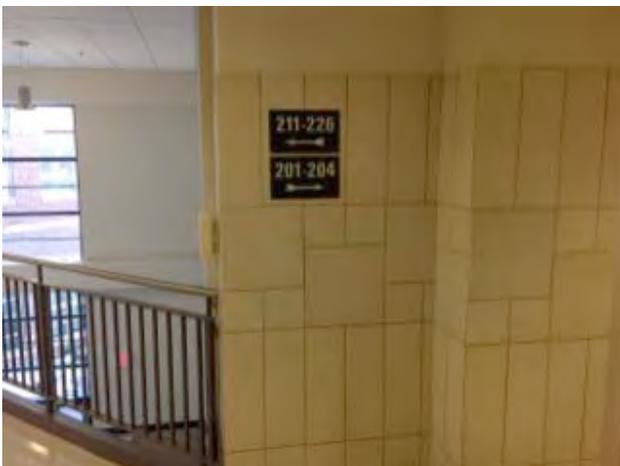
Photo 11

- Braille was typically missing from signage; (Photo 11)
- Classroom designation signage is covered by artwork;
- Accessible entrances have worn or are missing ISA symbol.

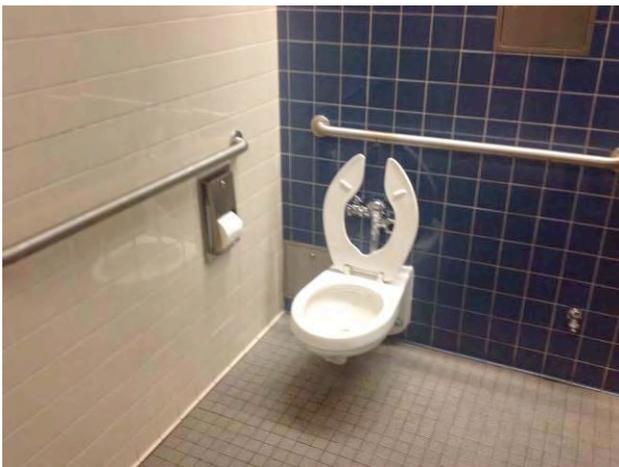
Photo 13

- Dispensers and coat hooks are missing or are mounted incorrectly; (Photo 13)
- Trash receptacles made intrude on clear floor space.

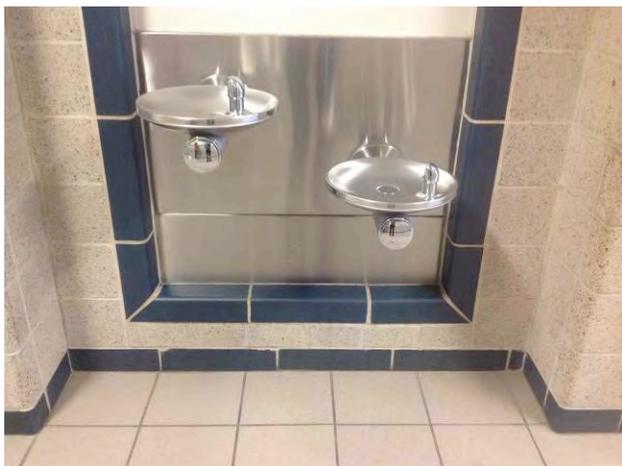
Photo 15

A hi-lo drinking fountain was inset approximately 6 inches into the wall face. That inset eliminates much of the knee and toe clearance, making the drinking fountain inaccessible. (Photo 15)

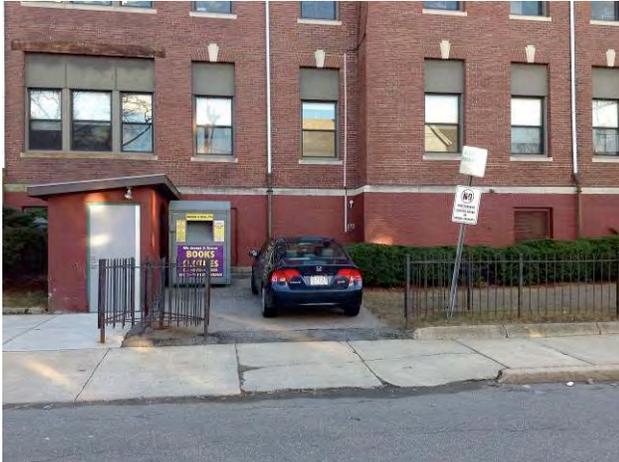
Photo 1

The entrances to the school are directly connected to the sidewalks along Willow, Kidder, and Josephine Avenues. Although the sidewalks and curb ramps are in good condition, a deteriorated and excessively sloped section of the sidewalk can be found along the vehicular curb on Kidder Avenue. (Photo 1)

1. Repair or replace the sidewalk along the vehicular curb on Kidder Avenue.

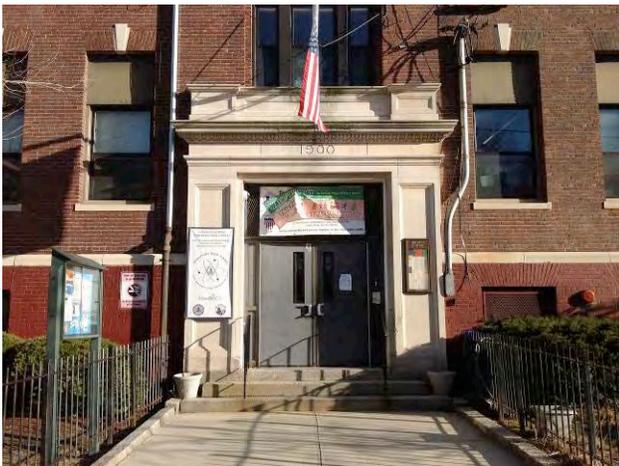
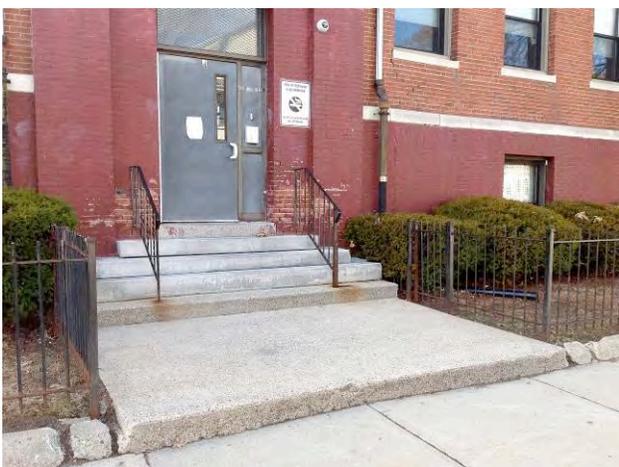
The building has entrances on two sides – on Kidder and Josephine Avenues. Neither entrance is accessible since stairways are provided to the interior floor a few feet above the exterior grade. Neither stairway has railings that comply with requirements for handrail extensions and cross section for grasping. (Photos 2 and 3)

Exterior steps and stairs at Kidder and Josephine Avenues are missing handrails or have handrails that do not meet dimensional requirements. (Photos 2 and 3)

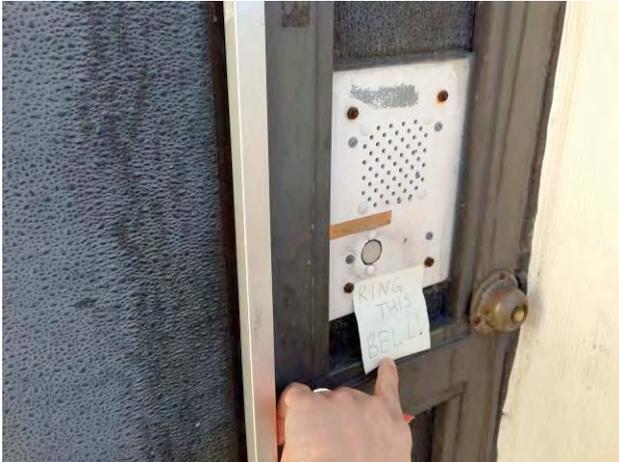
Photo 4

A buzzer and intercom are placed on the entry door on Willow Avenue and are out of reach for those who may not be able to navigate the stairway. No indication of the location an accessible entrance is offered at any of the entrances mentioned above. (Photo 4)

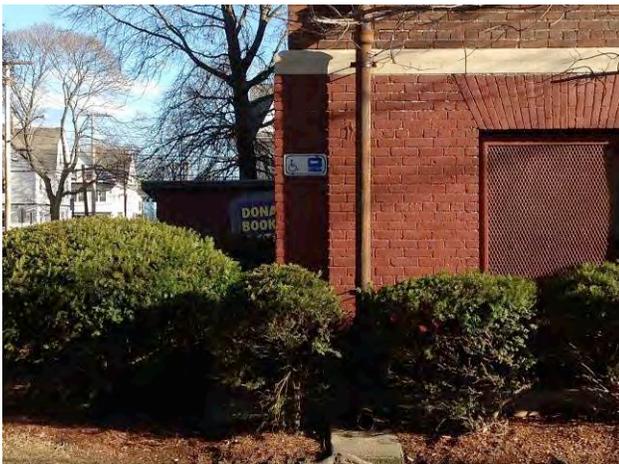
Photo 5

At both intersections, small signs with the International Symbol of Accessibility and the words 'Ramp' and 'Restroom' are mounted at the corners of the building several feet away from the sidewalks. (Photo 5)

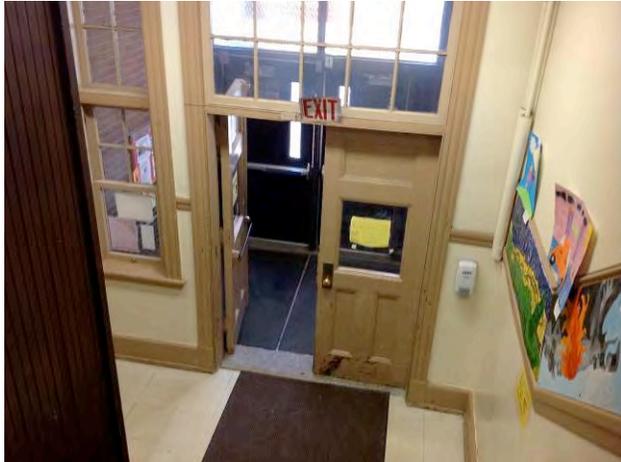
Photo 7

Throughout the building, several single- and double-leaf doors exceed the maximum allowable force required to open them and do not have the minimum clear width for accessible doors, especially the entry and vestibule doors. Several entry doors and doors to classrooms and toilet rooms have non-compliant hardware. (Photo 7)

1. When doors do not have the minimum clear width for accessible doors, either keep them open during regular hours or replace them with wider doors.
2. Replace door knobs with lever hardware.
3. Create a comprehensive maintenance program and schedule to check and adjust the opening force of all exterior and interior doors. Where not possible, either keep heavy doors open during regular hours or add automatic openers.
4. Provide an automatic opener wherever doors do not have the required maneuvering clearance on their latch side. Prioritize entry doors and doors to toilet rooms.

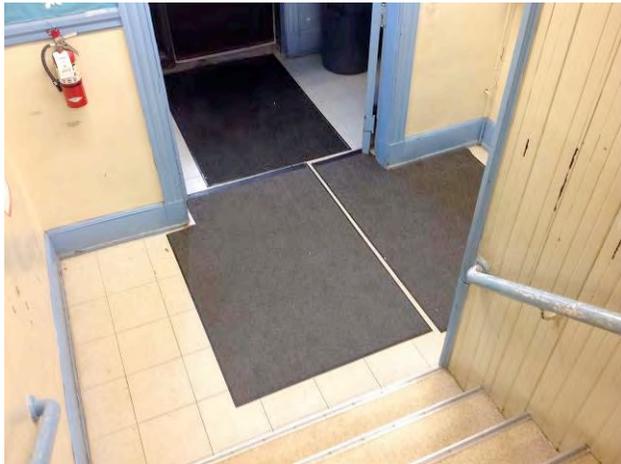
Photo 8

At circulation areas as well as certain offices, several weather mats are not secure and can become tripping hazards to faculty and students. (Photo 8)

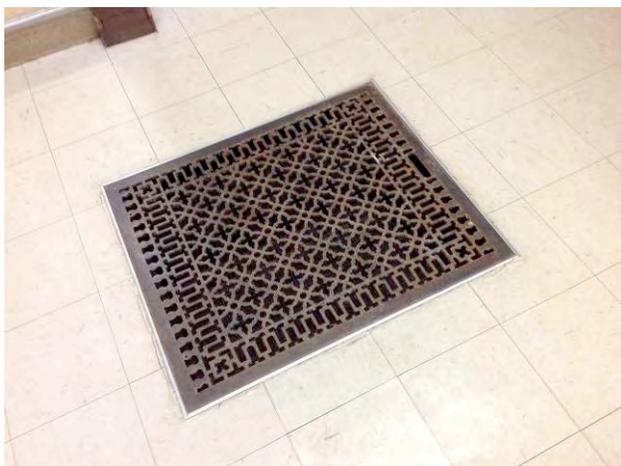
Photo 9

Similar to weather mats, grates with large openings can also become tripping hazards to customers and staff. (Photo 9)

1. Secure all weather mats with industrial-strength double-stick tape. Alternatively, replace them with recessed walk-off mats or grates.
2. Replace grates with opening no wider than 1/2-inch.

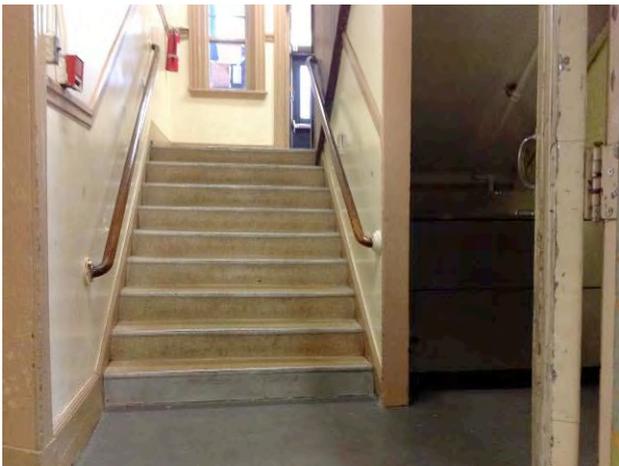
Photo 11

At both entrances, egress stairways offer vertical circulation to all floor levels. Neither stairway has compliant handrails. (Photo 11)

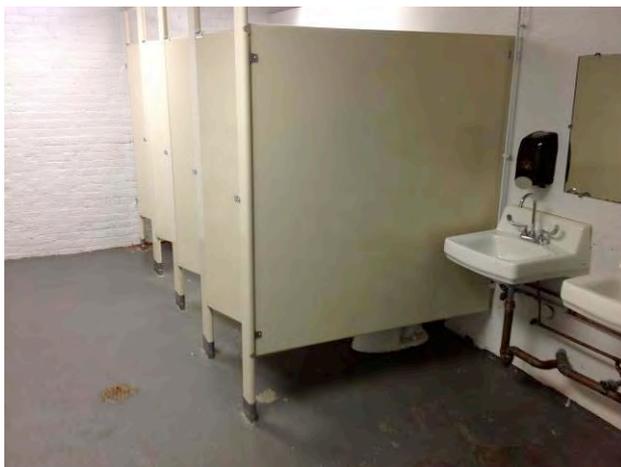
Photo 14

A unisex, multi-user toilet room for student use is located on the basement level. This toilet room is inaccessible because the lavatories are mounted too low which obstructs the required knee clearance, plumbing underneath the lavatories is unprotected, the mirror above the lavatories exceeds the maximum allowable height, and accessible urinals and stalls are not provided. (Photos 13 and 14)

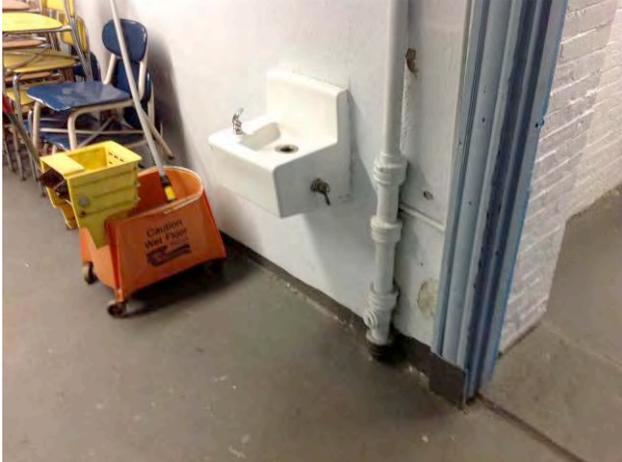
Photo 16

Drinking fountains are provided on most floor levels. All are inaccessible because they lacked sufficient clearance and or had inaccessible controls that required twisting.

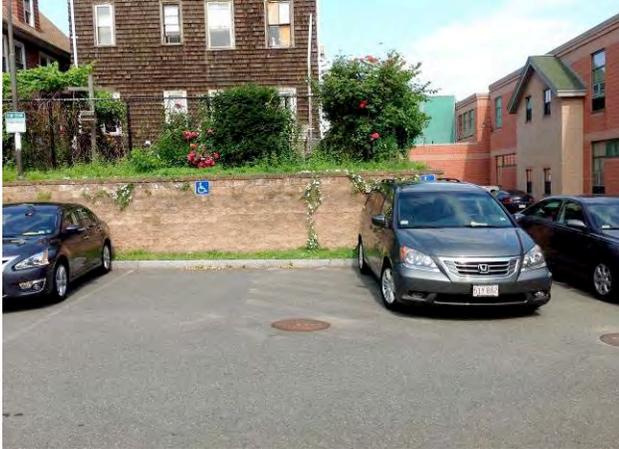
Photo 1

In the parking lot off Franklin Street there are 11 parking spaces total and one accessible parking space with 96-inch wide access aisle that is not highly visible and missing sign. At the parking lot off Turner Court there are 12 parking spaces total with two accessible parking spaces that have a 96-inch wide access aisle that is not highly visible. Additionally, the van designated and standard M.G.L. sign is missing, and the ISA signs are below 5 feet above the ground. (Photo 1 and 2)

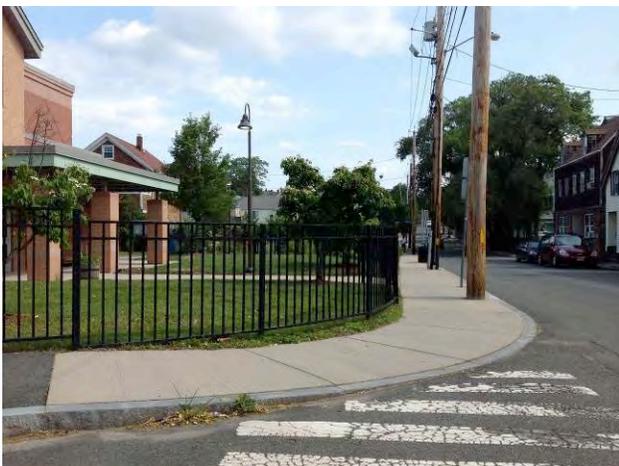
Photo 3

Sidewalks abutting the Capuano School along Glen and Franklin Streets were rebuilt when the school opened. No major issues were identified apart from portions of sidewalk abutting the soccer field that had cross slopes in excess of 1:50 and catch basins that had openings greater than ½ inch and were tripping hazards. At least one curb ramp lacks a level landing. (Photo 3)

1. Rebuild curb ramps that lack level landings
2. Replace drains and catch basins that have openings greater than 1/2 inch or are tripping hazards.
3. Where possible reduce cross slopes.

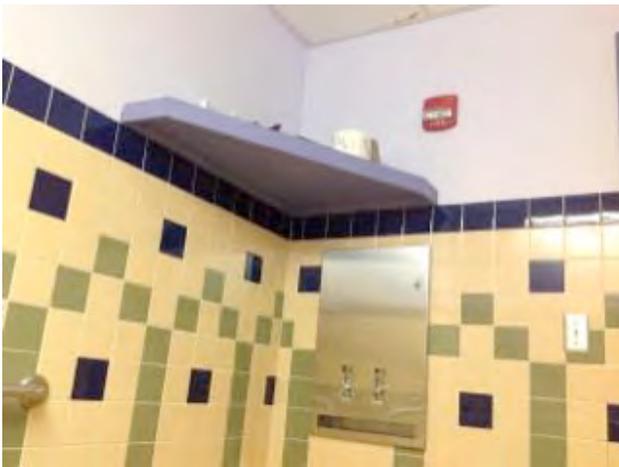
Photo 6

- hanging TVs and network/data boxes;
- automatic external defibrillator
- fire extinguishers;
- underside of egress stairways; (Photo 5)
- shelves. (Photo 6)

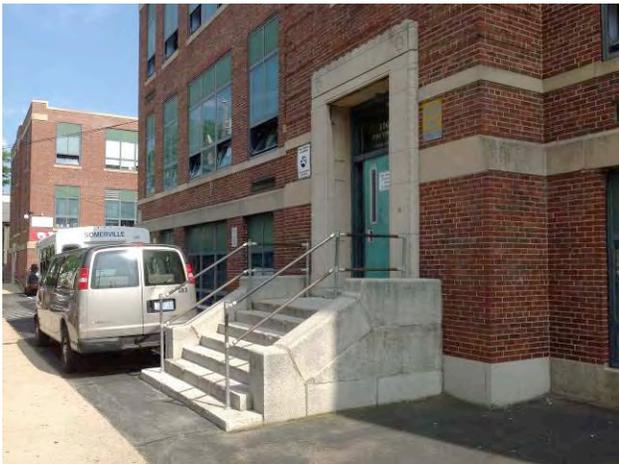
Photo 5

Along Bonair and Otis Streets, multiple other inaccessible entrances can be reached via stairways. Neither stairway has railings that comply with requirements for handrail extensions and cross section for grasping. (Photos 5 & 6)

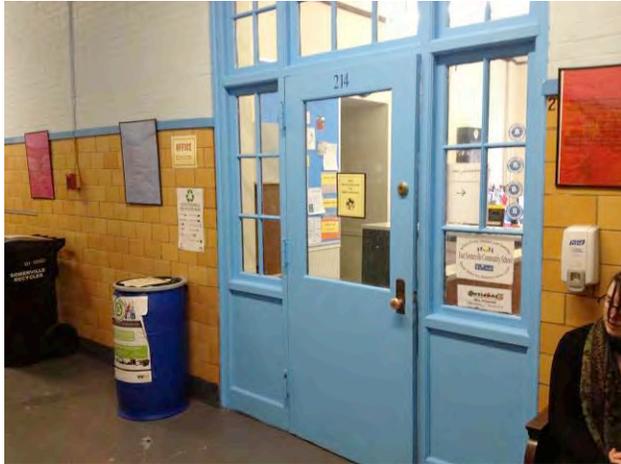
Photo 7

Additionally, numerous doors have non-compliant hardware and do not have the minimum maneuvering clearance required to open them. (Photo 7)

1. When doors do not have the minimum clear width for accessible doors, either keep them open during regular hours or replace them with wider doors.
2. Replace door knobs with lever hardware.
3. Create a comprehensive maintenance program and schedule to check and adjust the opening force of all exterior and interior doors. Where not possible, either keep heavy doors open during regular hours or add automatic openers.
4. Provide an automatic opener wherever doors do not have the required maneuvering clearance on their latch side. Prioritize entry doors and doors to toilet rooms.
